Earthquake Risk and Slope Stability in Jerusalem

DANIEL WACHS and DOV LEVITTE

Geological Survey of Israel

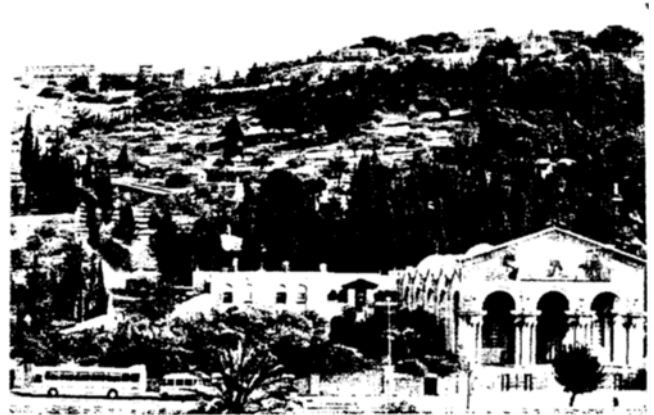
Figure 2. The old landslide in the Mount of Olives. The area clear of trees above the Gethsemane church is the slide unit. Immediately above it, partly hidden behind the trees, is the main scarp (*large arrow*). Younger, smaller scarps can be seen in the left portion of the main slide unit (*small arrow*).

Figures 2 and 3 show the scarp of the landslide, and the slide unit. The scarp is 10 m high and the slide unit has the typically hummocky surface. In some places, new, younger scarps have formed on the slide unit. These scarps and tilted trees indicate that the colluvial material on the surface is unstable.

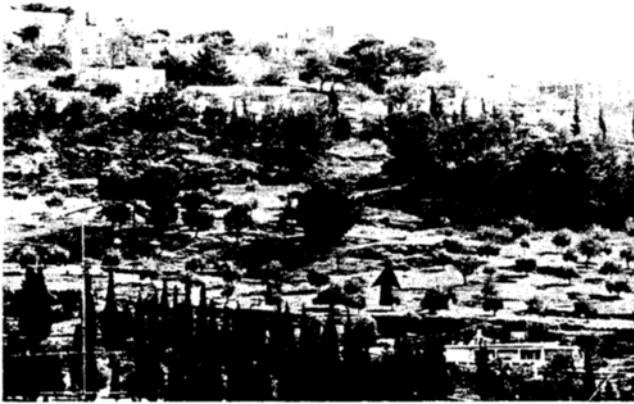
Figure 3. Detail of Figure 2, showing the main scarp and the slide unit. The small trees on the slide unit are young olive trees 2–3 m high. The light spot on the main scarp is a recent small scarp. The hummocky surface and the younger scarps (*arrow*) of the colluvial material on the surface of the slide unit are best seen in the center of the photograph, where the large trees are growing.
